Weekly Update
Aug 28 – Sept 3

Repair Work

Devil's Slide (post mile 39.14)

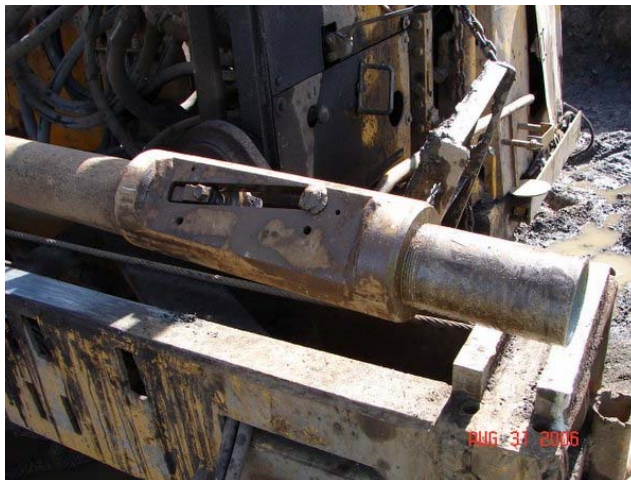
- After installing the horizontal drains approximately 40 feet below the roadway, Jensen Drilling performed the last operation to perforate the steel casings.

Perforating steel casings for the drains

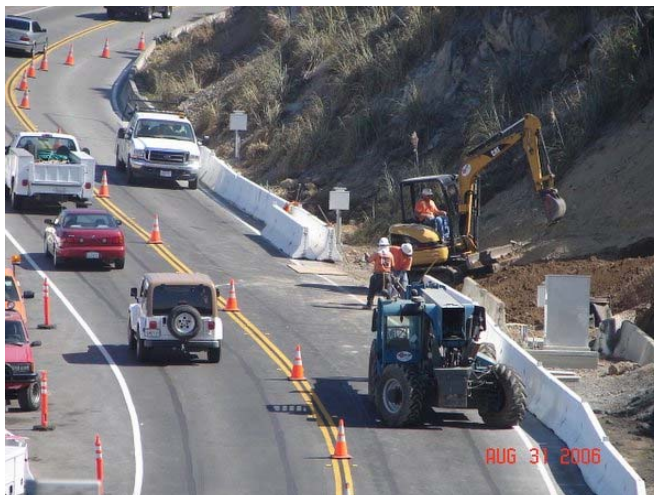
- Work started this week on the rock catchment drainage system above the road.

One way traffic control during drain system work

- One way traffic control was in effect on 8/31/06 and 9/1/06 to allow drainage work at the rock catchment area to proceed.

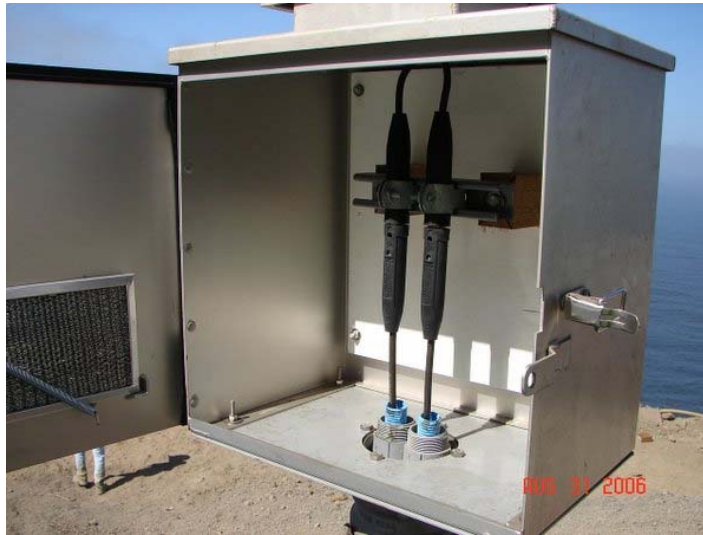
- Work on the slide sensor system continued and is almost complete. Battery back ups, programmable controllers and wireless modems still need to be installed. Part of the sensor system is shown in the photograph below.

Connectors will be broken by significant slide movement

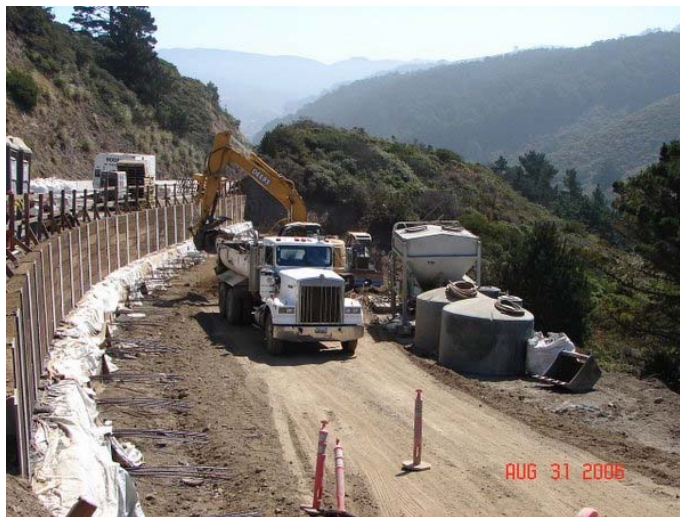
- The concrete waler wall will be sufficiently cured next week to allow tie back stressing to take place. Minor excavation work was completed below the waler wall.

Excavation work in progress
